TECHNICAL INVESTIGATION NO 778

EVALUATION OF NEW IROQUOIS TORQUEMETER PN 73-30-1

JUNE 1982

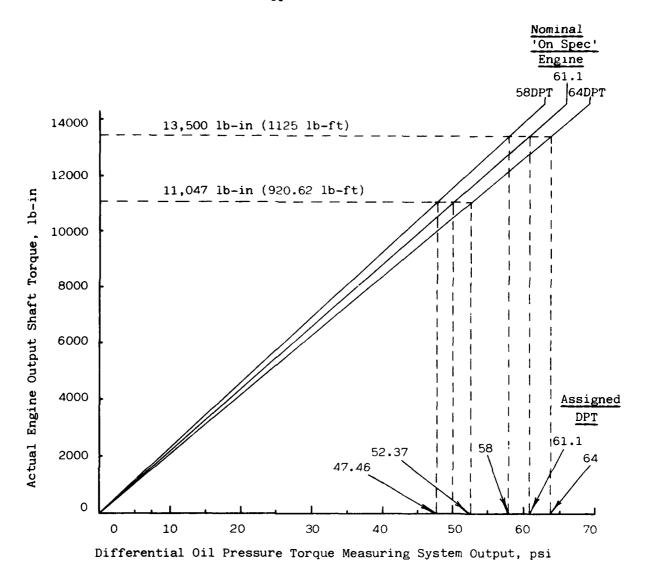
FIGURE 3.1 - DIFFERENTIAL OIL PRESSURE VS ACTUAL TORQUE

- a. <u>Differential Oil Pressure Versus Actual Torque</u>. Differential oil pressure versus actual engine torque is assumed to be linear over the range and to converge on the origin for different DPT engines. This is illustrated in Figure 3.1.

b. Adjustment At 11,047 lb in Actual Torque. Given the linear relationship illustrated in Figure 3.1, at 11,047 lb in actual torque (the transmission limit equivalent to 50.0 psi torque for the nominal 'on specification' 61.1 DPT engine) the 64 DPT engine produces a differential oil pressure of approximately 52.37 psi (ie 2.37 psi in excess) and the 58 DPT engine produces approximately 47.46 psi (ie 2.54 psi low). A reasonably correct indication should be obtained by adjusting the cockpit indicator up 2.54 psi for a 58 DPT engine, down 2.37 psi for a 64 DPT engine and zero for the 'on specification' 61.1 DPT engine. Annex B, Figure 1 is based on this logic.

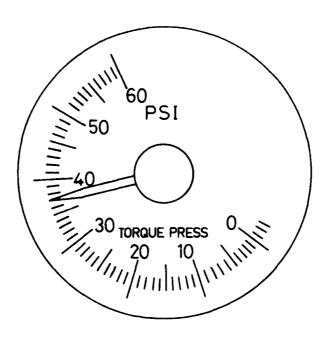
FIGURE 3.2 - MODIFIED GRADATION MARKS AND POINTER

- 3.7.2 Scale Obscuration. The needle and all instrument face markings were fully in view from the pilot's seat. From the co-pilot's seat, the outer sections of the scale markings were obscured by the instrument bezel in the range 30 psi to 55 psi. Markings greater than 55 psi were completely obscured by the top left instrument post light. Confined area operations often demand that the pilot's attention is directed outside the helicopter to maintain clearances from obstructions during approaches and departures. The co-pilot is required to monitor engine performance (primarily torque) and clearances on the left side of the aircraft. Obscuration of torquemeter markings in the range greater than 30 psi could cause misreadings. Alternatively, the co-pilot may compensate for this deficiency by leaning to the right so that all markings are visible. This would detract from his secondary task of monitoring clearances on the left side of the aircraft. Obscuration of instrument markings in the range greater than 30 psi, as viewed from the co-pilot's seat, was unsatisfactory. This may be overcome by pilot compensation or alternatively by adopting the modifications recommended in Paragraph 3.7.3.

- b. Pointer Taper and Length. The pointer should be more finely tapered (eg similar to the EGT indicator pointer) and extended slightly so that the tip reaches approximately the middle of the gradation marks. This would help to reduce parallax errors.

- 3.7.3 <u>Pointer and Gradation Marks</u>. The following modifications to the pointer and gradation marks are recommended to help alleviate deficiencies outlined in Paragraphs 3.7.1 and 3.7.2:

- a. <u>Incremental 5 psi Marks</u>. The gradation marks at increments of 5 psi should be extended inwards instead of outwards. This would help compensate for the obscuration of the markings when viewed from the co-pilot's seat.

A sketch of the indicator face, incorporating the proposed modifications, is shown in Figure 3.2.

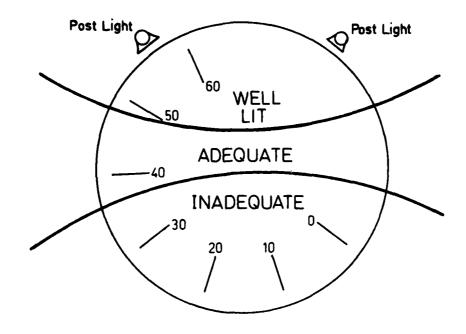
FIGURE 3.3 - LIGHTING LEVELS

- Lighting. The instrument was lit by two red filtered post lights 3.7.5 mounted above the instrument at the approximate relative positions of eleven and one o'clock. Instrument lighting was assessed at night with the lighting intensity adjusted to approximately mid-range (representative of the selection made by most pilots for night operations). Figure 3.3 illustrates the light dispersion pattern which resulted. The post light at the one o'clock position virtually provided no illumination of the scale area and served no useful purpose. The red-painted gradation mark at 50 psi blended with the other gradation marks and was difficult to discern from other markings. Inadequate lighting of the scale from zero psi to approximately 35 psi will cause difficulty in reading engine torque during cruise flight and descent when conducting night operations. The night-lighting of the instrument was unsatisfactory and should be corrected to improve lighting in the zero to 35 psi area. Failure to correct this deficiency may force use of higher than necessary overall lighting levels to accommodate the inability to see this area of the instrument.

- 5.3 The instrument should be modified so that 'zero set' adjustment is easier (Paragraph 3.3.2).
- 5.4 The night-lighting of the instrument should be improved so that the whole of the scale is adequately lit (Paragraph 3.7.5).

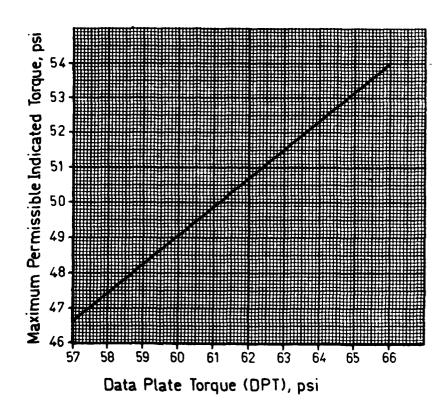
FIGURE 3.4 - MAXIMUM PERMISSIBLE TORQUE VS DPT

3.10.1 If significant delays occur before introduction of a suitable production torquemeter, an interim method to display maximum permissible torque may be required. The method of this adjustment could take the form of that used by the RNZAF (see extract at Annex C). If the logic of Paragraphs 3.4.1 to 3.4.3 is used, the corresponding decal values of maximum indicated torque should be based on the 'reverse' of Annex C, Figure 1. This is shown in Figure 3.4 below.

5.10 If significant delays occur before introduction of a suitable production torquemeter, an interim method of displaying maximum permissible torque should be adopted (Paragraph 3.10.1).
